Smoke and Dye Testing Summary

High Level Sewershed

Run Summary

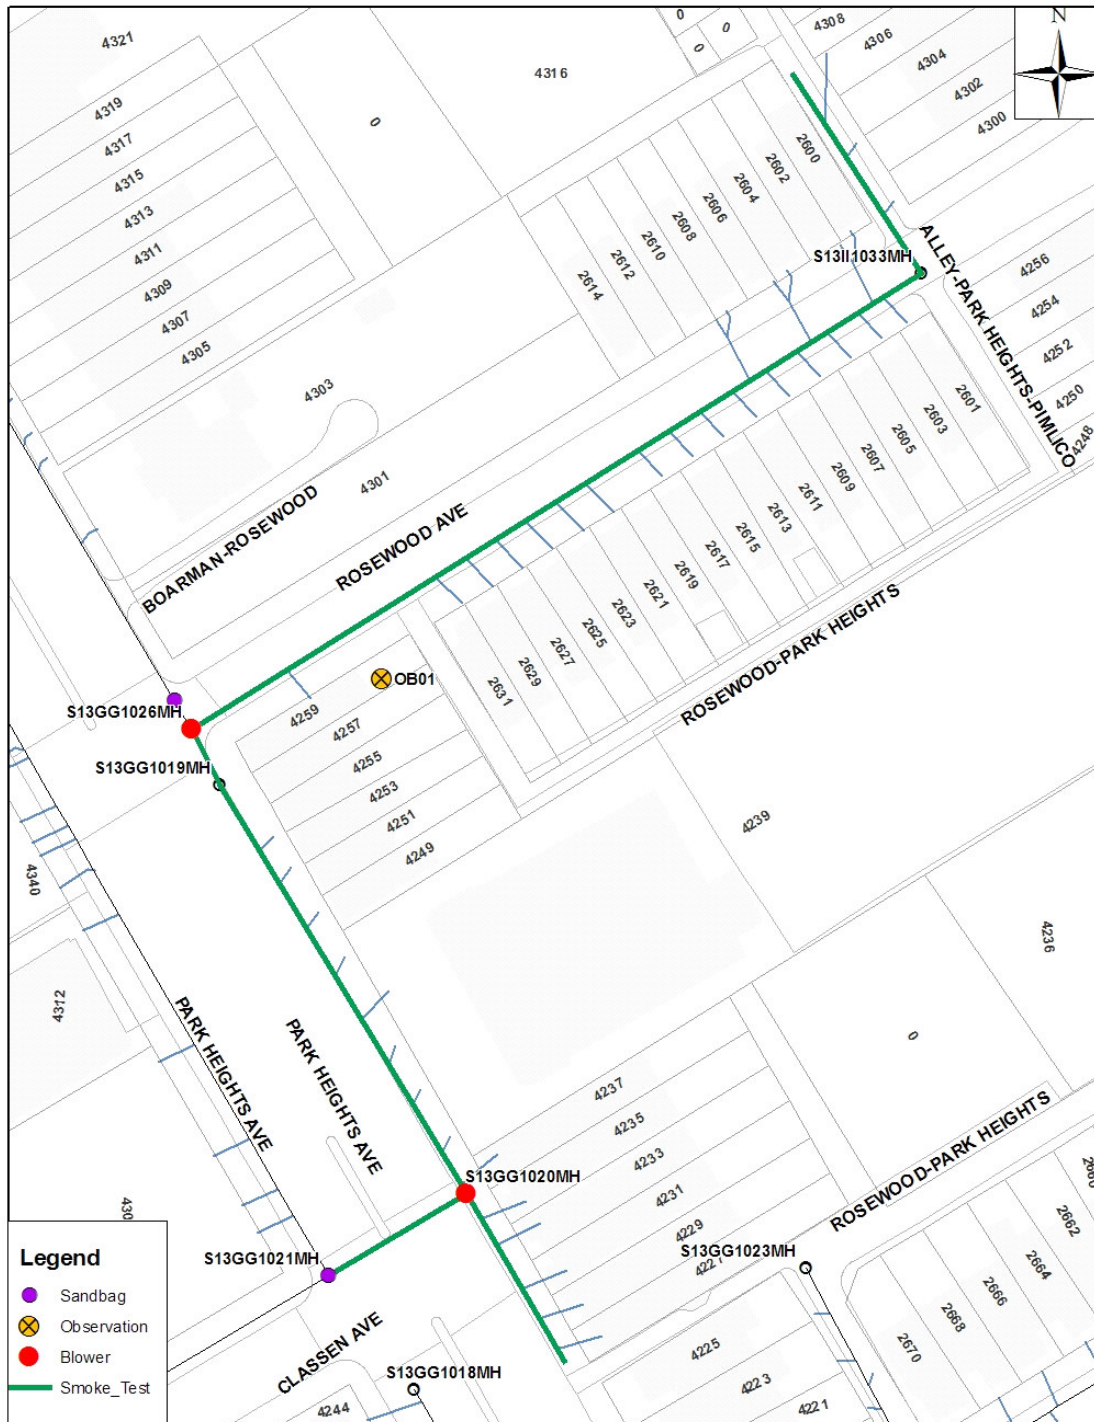
Picture \S1028-046-OB01-P01.jpg

Comments Smoke from cleanout in back yard. 4259 Park Heights Ave.

Comments Back of house, 4259 Park Heights Ave.
